SRI Evaluation Sheet

A/C Type : A330										
SRI Number : 24960 & 24964										
<input checked="" type="checkbox"/> System <input type="checkbox"/> Cabin <input type="checkbox"/> Structure										
<input type="checkbox"/> ALD	<input type="checkbox"/> ALP	<input type="checkbox"/> ALC	<input checked="" type="checkbox"/> SDR	<input type="checkbox"/> LD						
<input type="checkbox"/> Accidental	<input type="checkbox"/> Environment	<input type="checkbox"/> Fatigue	<input type="checkbox"/> ALM	<input type="checkbox"/> EXT Repair						
<input type="checkbox"/> ALCA	<input type="checkbox"/> OPS									
Prepared by : Syamsurisal			Sign:							
Date : 19-July-2018										
ATA : 32										
Event Month (YYMM) : 1801										
PROBLEM STATEMENT : PK-GPM and PK-GPP GREEN HYDRAULIC LEAK FROM FLEXIBLE HOSE.										
PROBLEM DESCRIPTION : <ul style="list-style-type: none"> - On 1st of January 2018 GA860 PK-GPM landed at HKG with hydraulic leak from normal brake flexible hose. - On 03rd of July 2018 GA825 PK-GPP experience hydraulic leak from normal brake flexible hose.

Chronology of event : PK-GPP

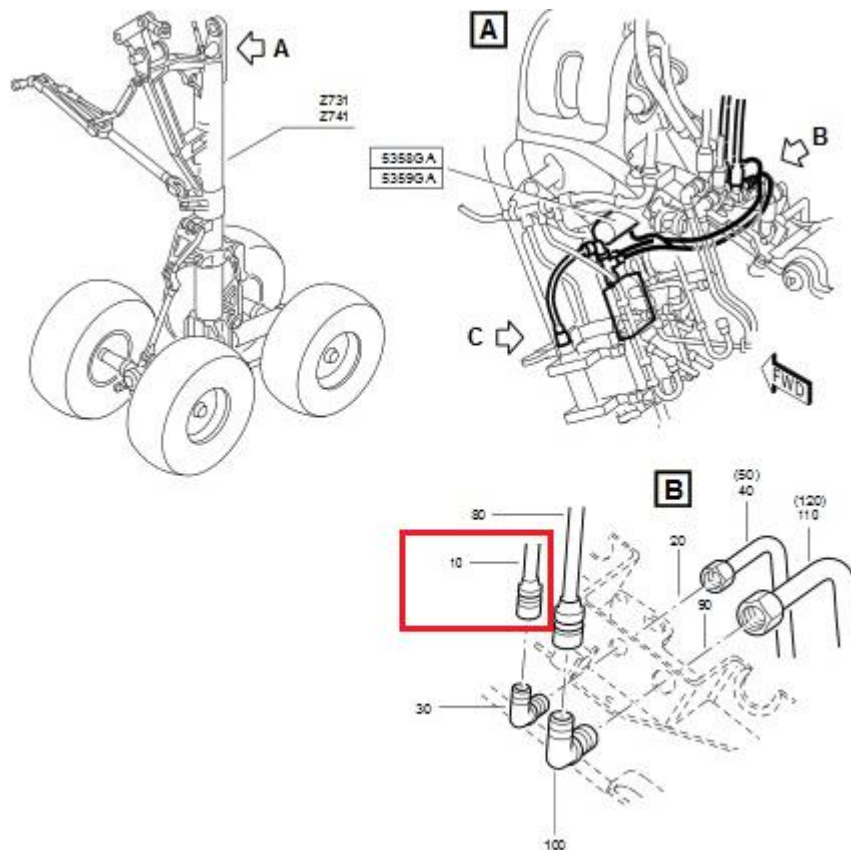
Figure 2 Flexible Hose Position

- On 03rd of July 2018 GA825 PK-GPP experience hydraulic leak from normal brake flexible hose.
- Performed flexible hose replacement and operational test and leak check performed result good and no leak detected.

Solution Description	Effectivity	Resp. Unit	Start Date	Finish Date
Speed up accomplishment TO-10000082248-002-00 (Replacement of hose PN 201042322) for registration more than 4 years.	PK-GPA to PK-GPV	TLP	19-July-18	14-Dec-18

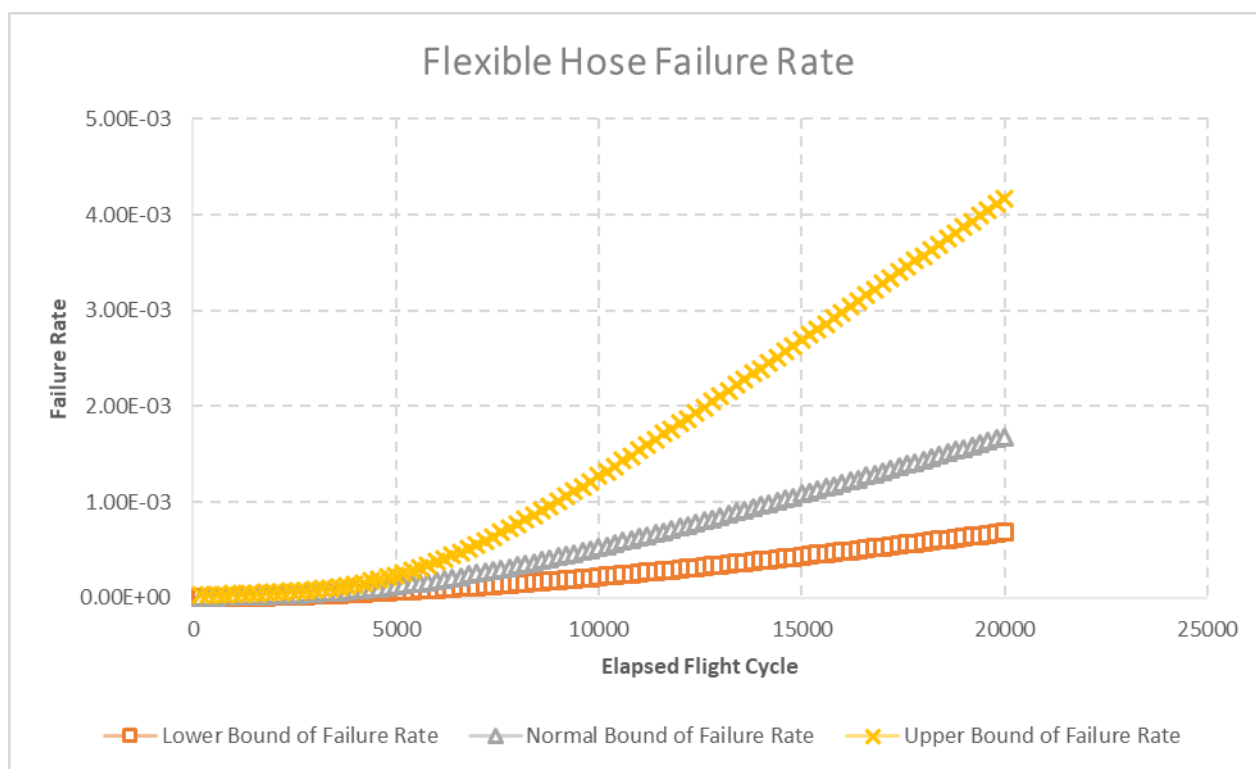
Figure 4 Failure rate

Base on above data we've performed Weibull analysis with classic method. The result shown MTTF is 7430 FC (3.7 years).

Flexible Hose PN 201042322 is recommend by Airbus for repetitive replacement refer to ISI 32.00.00157 every 4 years and based on our database the MTTF interval is 3.7 years. However, the approval for replacement issued on the beginning of 2018. It takes time to prepare material and ground time for the aircraft. To ensure the problem isn't happened again, flexible hose with more than 4 years needs to be replaced soon.

Note: root cause of the problem is reliability issued on hose PN 201042322.
