A/C Type : A330				
SRI Number 311870				
<input checked="" type="checkbox"/> System	<input type="checkbox"/> Powerplant	<input type="checkbox"/> Cabin	<input type="checkbox"/> Structure	
<input checked="" type="checkbox"/> ALD	<input type="checkbox"/> ALP	<input type="checkbox"/> ALC	<input type="checkbox"/> SDR	<input type="checkbox"/> LD
<input type="checkbox"/> Accidental	<input type="checkbox"/> Environment	<input type="checkbox"/> Fatigue	<input type="checkbox"/> ALM	<input type="checkbox"/> EXT Repair
<input type="checkbox"/> ALCA	<input type="checkbox"/> OPS			
Prepared by : Arsha Dwiparizka		Sign:		
Date : July 15, 2025				
ATA : 29 and 32				
Event Month (YYMM) : 2406				
<b>PROBLEM STATEMENT</b> In May 2024, Hydraulic Leaks become driver and triggered the Alert Level Delay. The drivers are EDP, flexible hose PN 201042198 on the MLG Pitch Trimmer, and flexible hose PN F0003160004500B FIN 5261GG.

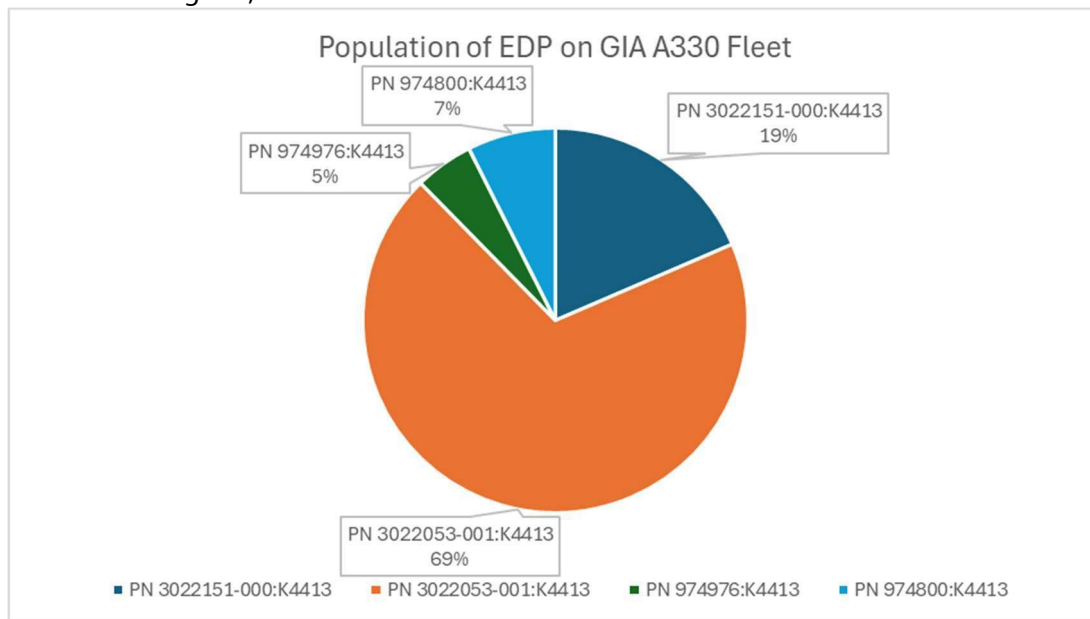
Figure 1. Population of EDP on A330 GIA Fleet

There are several Part Numbers of Engine Driven Pump on A330 GIA Fleet, which divided into below diagram,

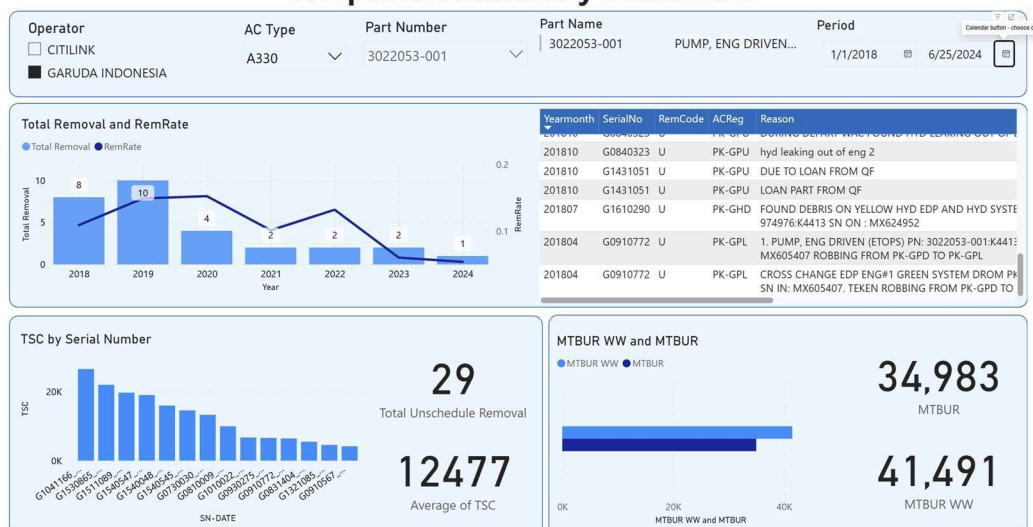
Figure 2. Reliability and Unscheduled Removal of PN 3022053-001

From the figure above, the GA MTBUR is still below the worldwide MTBUR. The shop report shows that the problem is from internal leaks and the outlet fitting however, not all the SVR has been acquired. This problem has been addressed by introducing the new PN 3022151-000 refer to AIRBUS TFU 29.11.00.016- "Hydraulic Engine Driven Pump (EDP): Outlet Rosan fitting seepage with Eaton PN 3022053-000/-001 (PV3-300-EA2/-EA2A) / Rolls-Royce Engine / Green EDPs". To have better decision and effective preventive action, the rest of SVR's still being monitored.

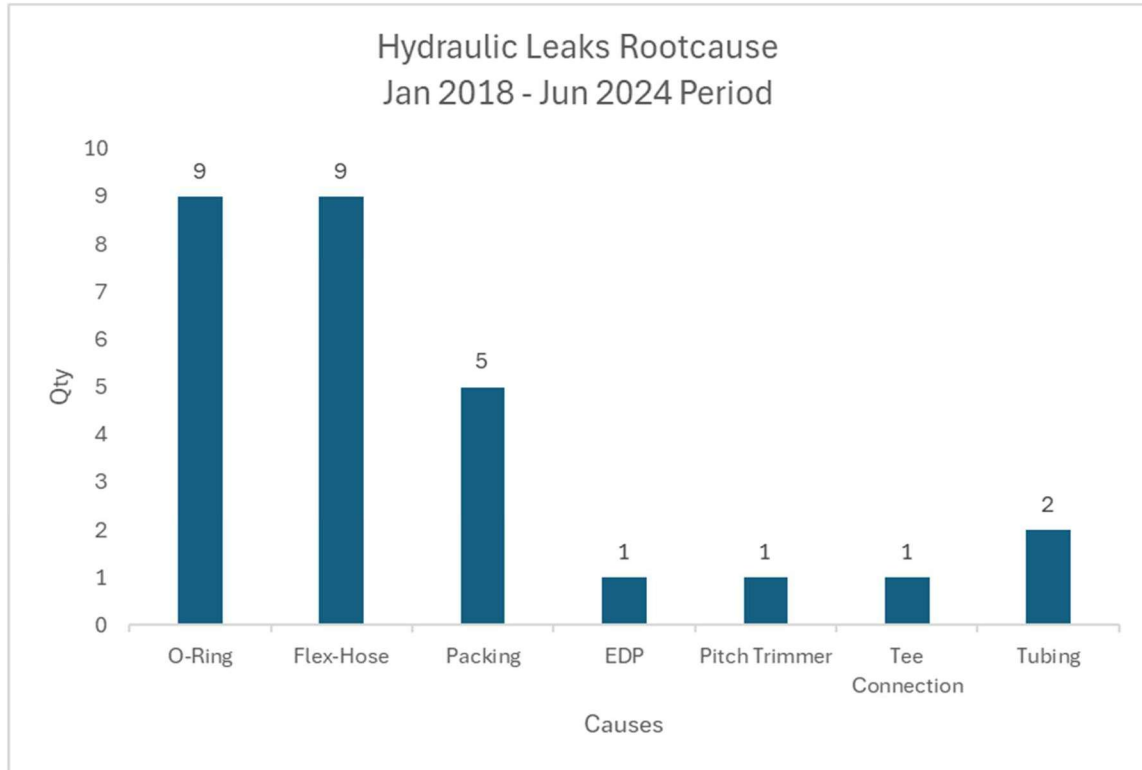
Figure 3. Hydraulic Leaks Rootcause

The figure above shows the rootcause of hydraulic leakages are mostly due to degraded o-ring and failure of flexible hose.
