A330/340 FAM - Preventing External Hydraulic Leaks

Reference: 29.00.00158

This article gives a summary of the latest information and available modifications addressing hydraulic leaks on A330 and A340 aircraft.

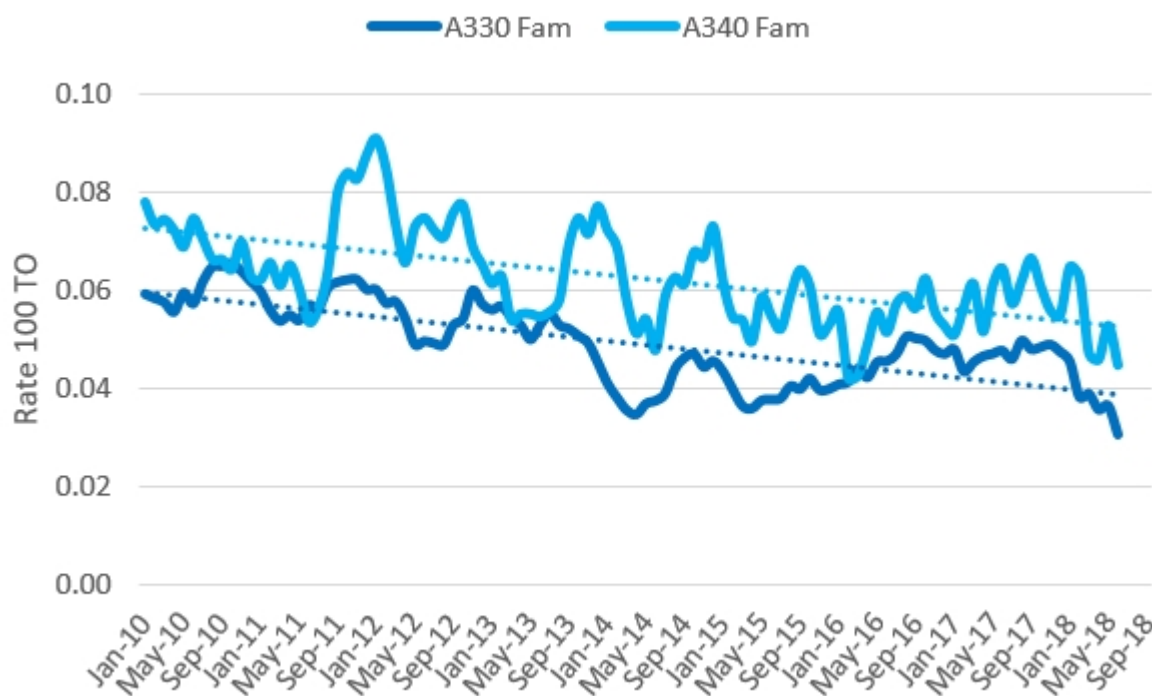
Due to their impact on aircraft dispatch reliability, hydraulic leaks are a concern for operators. The following charts have been produced based on the leak events reported by the operators. It presents the fleet wide operational interruption rate per 100 Take Offs (T/O) due to hydraulic leaks in ATA chapters 27, 29, 32, 52 and 78 for the A330, A340 basic and for A3456 aircraft.

Airbus A330/340 – Hydraulic Operating Interruption

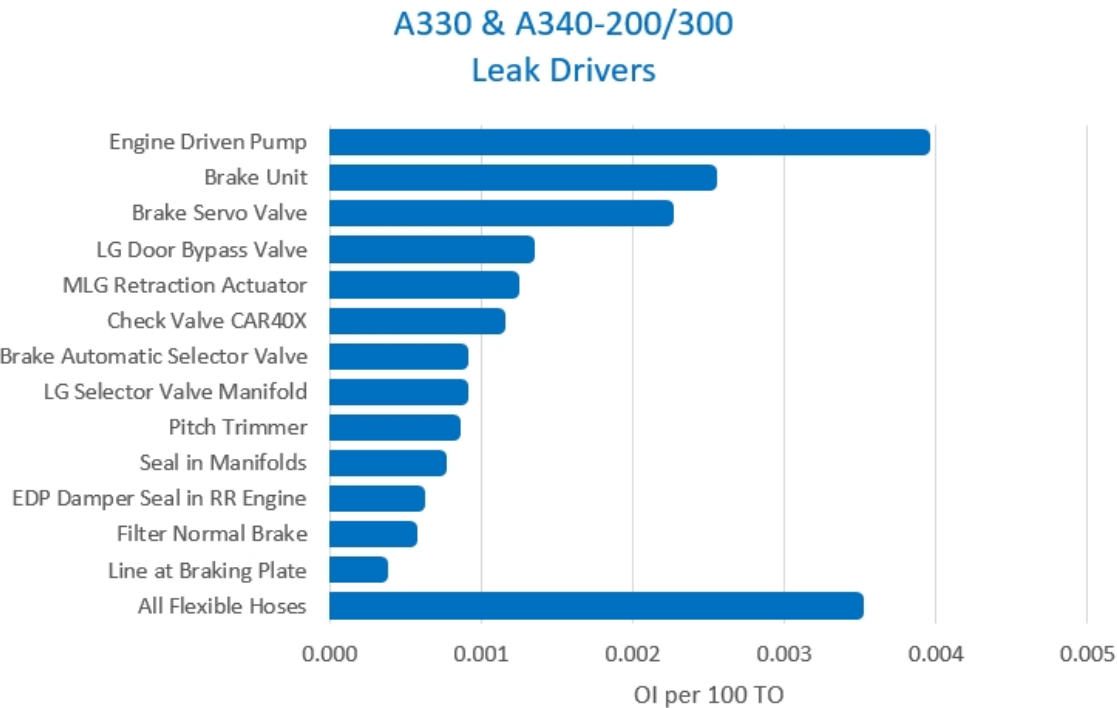
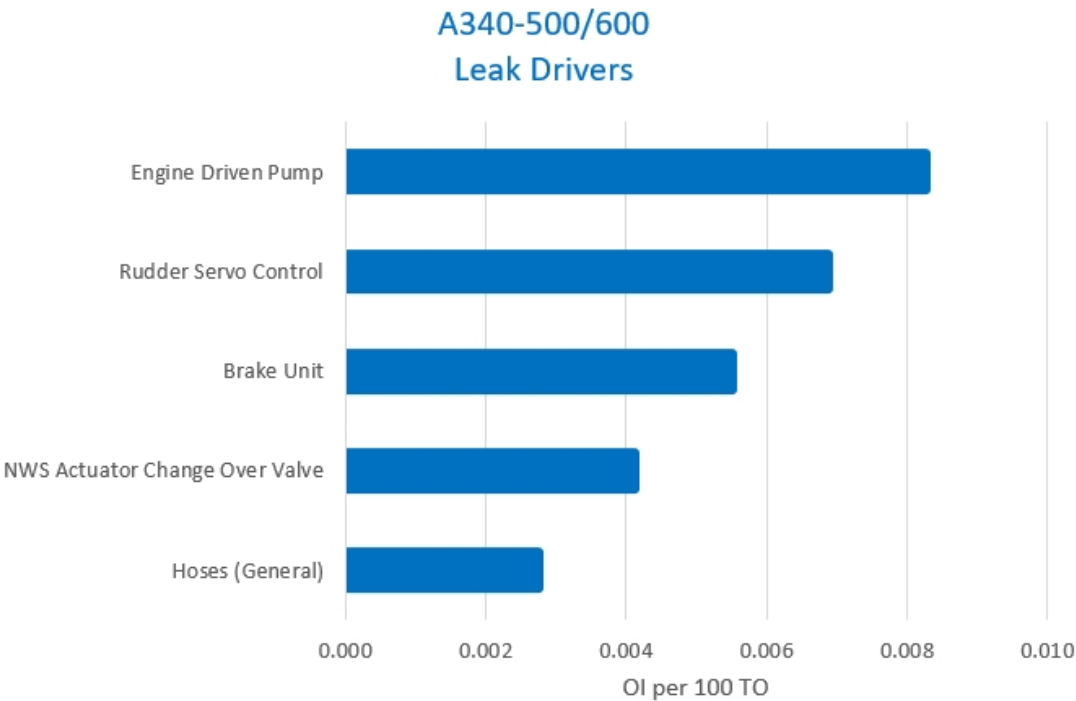
The following figures on hydraulic leak main drivers have been produced based on operational interruptions resulting from the leak events reported in 2015-2018.
